Caprivi Survey Report

Deon Joubert and Hannes Naude, 2 September 2016

The Elephant Survey System (ESS) was used to survey national parks within the Caprivi Strip of Namibia during August of 2016. This report provides an overview of the region surveyed and the system configuration used, some analysis of the data gathered and a detailed discussion and explanation of the problems experienced.

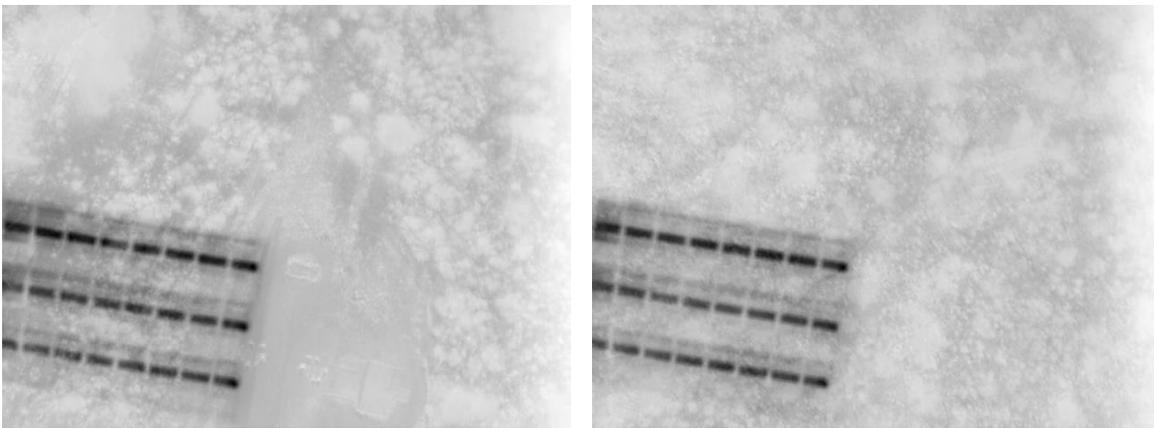
Examination of the IR images showed that there was a component broken within the camera, as can be seen in Figure 3. This added a third hypothesis, namely that this hardware failure in the IR camera was somehow affecting the rest of the system. As the IR camera is not used for elephant detection anymore, it was decided to disable the camera for the remainder of the survey. However, due to the design of the CaptureApp software in which the IR camera acts as the central synchronization source, this is not entirely trivial. To ensure that the CaptureApp would still function as expected, the IR camera was replaced with a software proxy that generates dummy images at the same nominal rate as the physical camera generates real images. This minimised the number and extent of the changes to the CaptureApp itself.

Figure 3. IR images from the first flight on the first day. Note the repeated obscuration in the lower left corner of both images, which indicates a broken component within the camera.

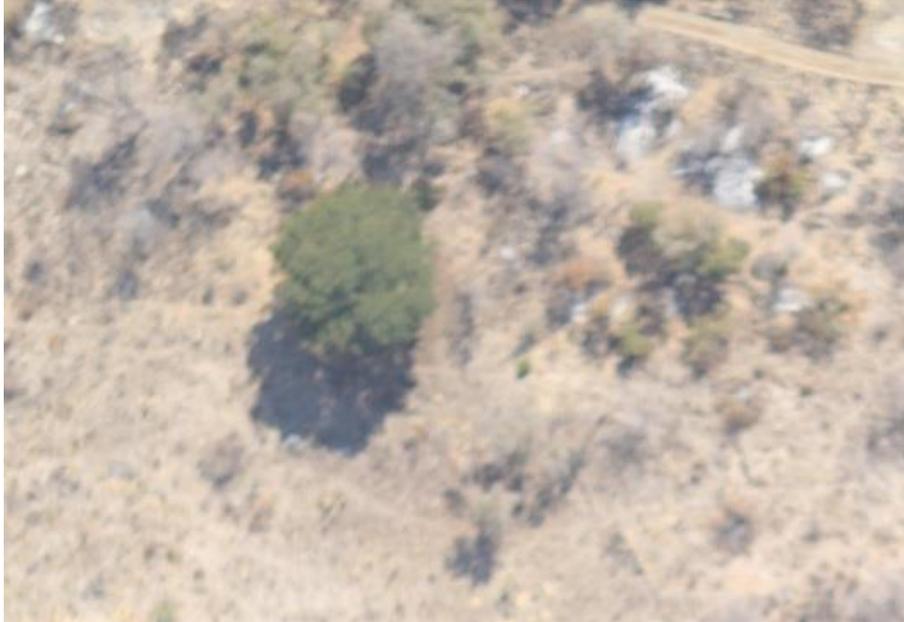
Inspection of the images captured during the third flight showed that the images were overexposed and slightly out-of-focus, an example of which can be seen in Figure 7. The camera was removed from the rig and the manual focus was tested at a distance of 600 m and was shown to be correct. It was decided that the out-of-focus appearance was a subjective effect caused by the high level of exposure within the image. To address this, the aperture for the lens was changed from 1.2 to 3.2.

Figure 7. An enlarged portion of a visual image captured during the third flight in the morning session of the second day. The slight out-of-focus appearance was initially attributed to the high level of exposure.

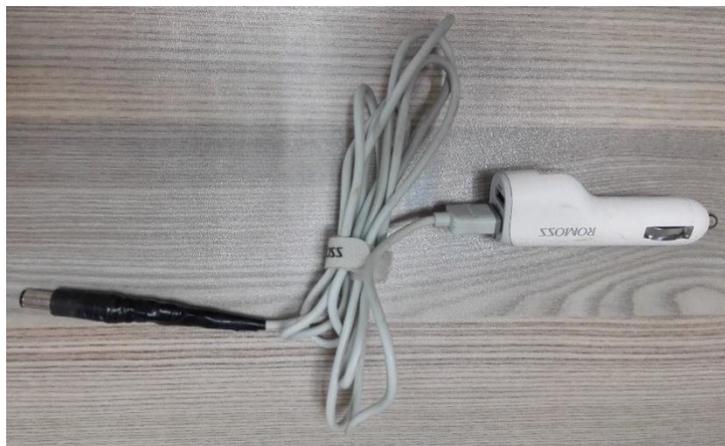
Due to the failure of the UPS we also had to come up with a new plan to get power to the laptop as its battery would never last for the two sorties we intended to fly in the morning. Earlier we had attempted to run a mains charger from Mr Aschenborn's inverter, but the aircraft electrical system could not supply sufficient current. We decided to cut the barrel connector from a mains charger and Mr Aschenborn set out to splice this plug to the car charger we had been using before the barrel adapter had been lost. The resultant power cable can be seen in Figure 8.

Figure 8. Ad-hoc laptop power cable, courtesy of Mr Aschenborn.

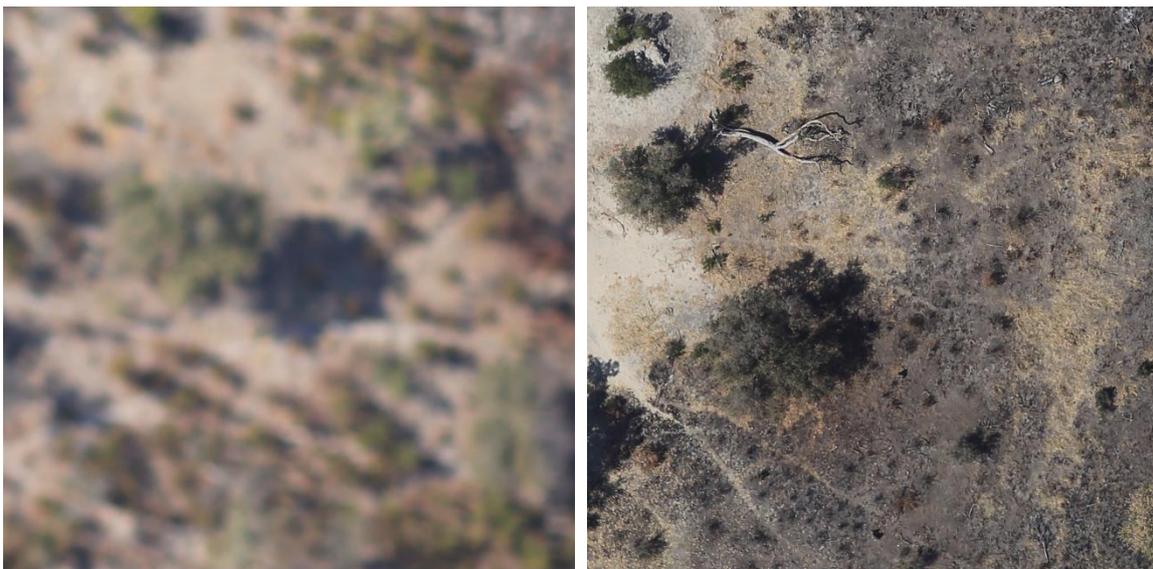
on the second day, it was found to indeed be out-of-focus, despite the fact that the focal point indicator on the lens was still on infinity. Further experimentation showed that the manual focus control was not a direct mechanism, rather the focus ring served as an electronic input into an internal mechanism. This, in turn, indicated that it would be impossible to lock the focus into an infinite position by fixing the focus ring control. Therefore, at a given focus setting the images would initially be crisp, but over time the internal mechanism would vibrate to a different position resulting in blurred images.

Therefore, it was decided to change the system so that the camera would again be set to autofocus mode. Even though it was expected that focus failures would occur sporadically, this would be preferable to having none of the image in focus. A third flight was carried out over the airfield, using the updated system. The images were seen to be crisp and in focus, as is evident in the comparison shown in Figure 10.

Figure 10. Comparison between an image from the first flight of the morning of the fourth day, with an image from the third flight, where the camera was set to autofocus mode.
